New Hampshire Volunteer Lake Assessment Program

2002 Bi-Annual Report for Big Island Pond Derry

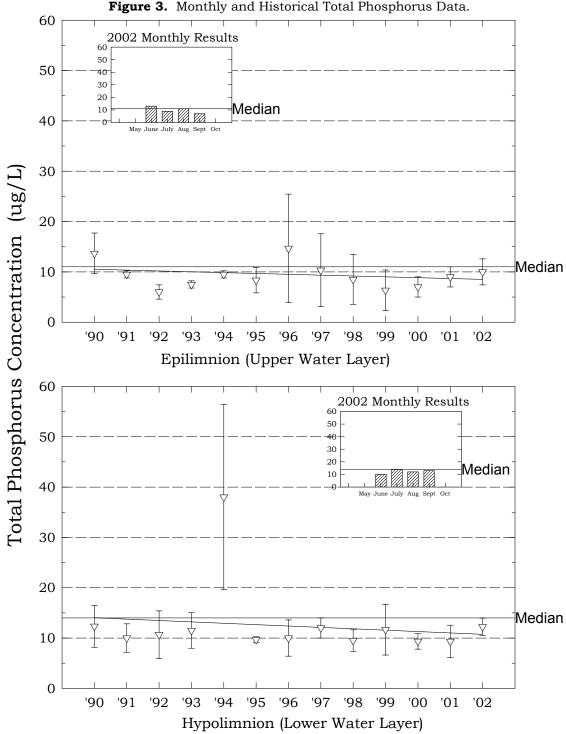
Big Island Pond, Derry Figure 3. Monthly and Historical Total Phosphorus Data.

Figure 3 and Table 8: The graphs in Figure 3 (Appendix A) show the amounts of phosphorus in the epilimnion (the upper layer) and the hypolimnion (the lower layer); the inset graphs show current year data. Table 8 (Appendix B) lists the annual maximum, minimum, and median concentration for each deep spot layer and each tributary since the lake/pond has joined the program.

The current year data for the epilimnion (the top inset graph) show that the total phosphorus concentration **decreased** from June to July, **increased slightly** from July to August, and then **decreased** from August to September. The total phosphorus concentration in June was **greater than** the state median.

The historical data show that the 2002 mean epilimnetic total phosphorus concentration is **slightly less than** the state median.

The current year data for the hypolimnion (the bottom inset graph) show that the total phosphorus concentration *increased* from June to July, *decreased* from July to August, and then *increased slightly* from August to September.

The historical data show that the 2002 mean hypolimnetic total phosphorus concentration is **slightly less than** the state median.

Overall, the statistical analysis of the historical data show that the total phosphorus concentration in the epilimnion (upper layer) and the hypolimnion (lower layer) has **not significantly changed** (either *increased* or *decreased*) since monitoring began in **1990**. Specifically, the total phosphorus concentration in the epilimnion and hypolimnion has **fluctuated**. (Note: Please refer to Appendix E for the statistical analysis explanation and data print out.)

One of the most important approaches to reducing phosphorus loading to a waterbody is to continually educate watershed residents about its sources and how excessive amounts can adversely impact the ecology and value of lakes and ponds. Phosphorus sources within a lake or pond's watershed typically include septic systems, animal waste, lawn fertilizer, road and construction erosion, and natural wetlands. If you would like to educate watershed residents about how they can help to reduce phosphorus loading into the lake/pond, please contact the VLAP Coordinator.
